BIOPAK 240R PRODUCT NOTICE

Concerning Lower Housing Sharp Edge Contacting Diaphragm

DATE: 06 January 2012

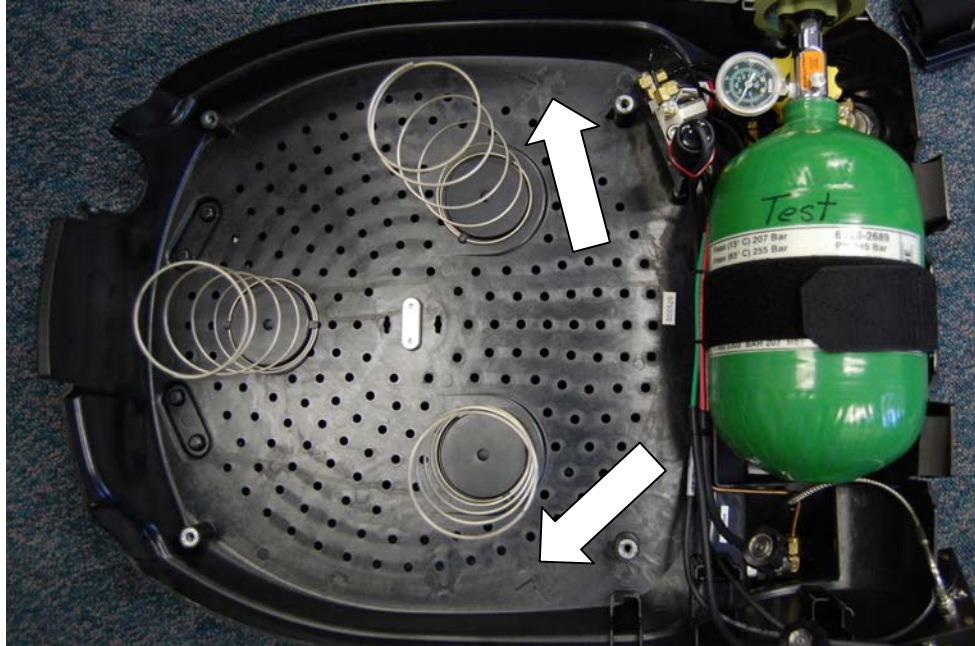
It has come to the attention of Biomarine that some molding flash located on the lower housing may be large enough to cause abrasion to the diaphragm of the breathing chamber. In some extreme cases the flashing has actually caused pin holes in the diaphragm that are discovered during leak testing of the turn around maintenance procedures.

The flash projections of the lower that may cause diaphragm damage are located on the internal side of the lower housing in the locations identified in the pictures below.

1. Remove the upper housing and inspect the depicted areas of the lower housing. If the lower housing has unusually high or sharp edges that contact the diaphragm, please take the following steps.
2. Remove the breathing chamber as per procedures provided in the Benchman Manual.
3. Inspect the lower housing in the locations identified above. If there is evidence of flash projections in the identified area, use 100-grit sandpaper to flatten the projections. Take measures to prevent sanding dust from entering into the pneumatic lines of the BioPak.
4. Clean the lower housing of dust.
5. Replace the breathing chamber as per procedure provided in the Benchman Manual.
6. Conduct Turn Around Maintenance on the BioPak as provided by the Benchman Manual.
7. Replace the upper housing.
